## WELDING INSPECTION REPORT

Resident Engineer: Pursell, Gary **Report No:** WIR-013972 Address: 333 Burma Road **Date Inspected:** 08-May-2010

**OSM Arrival Time:** 700 **Project Name:** SAS Superstructure **OSM Departure Time:** 1900 **Prime Contractor:** American Bridge/Fluor Enterprises, a JV

34-0006 **Bridge No: Component:** Tower

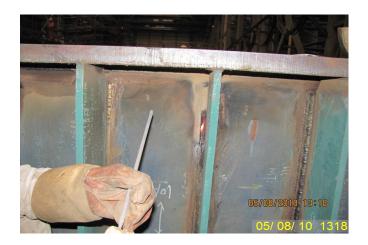
3. This QA inspector, Baskar Govindarajan, observed, ZPMC qualified welding personnel identified as 040533, 053869 perform FCAW welding on, Type 1 bearing stiffener in shear plate no. ND1-A24 and Weld joint identified as ND1-A24 A/B-23, 24. ZPMC CWI Identified as Mr. Tu Jun. The welding parameters as measured using QC's calibrated instruments appeared to be in general compliance with WPS-B-T-2332-TC-P4-F. (Photo attached)

4. This QA inspector, Baskar Govindarajan, observed, ZPMC qualified welding personnel identified as 251194 perform SMAW welding on, Web to stiffener on spare strut of North tower and Weld joint identified as ND1-STSA4-6-135mtr.-41. ZPMC CWI Identified as Mr. Yu dong ping. The welding parameters as measured using QC's calibrated instruments appeared to be in general compliance with WPS-B-T-2113.(Photo attached)
